BUT WHY?

Two years on from the collapse of a unique pedestrian bridge under construction at Florida International University, **Scott Snelling** seeks to identify the root causes in the hope such a tragedy does not occur again

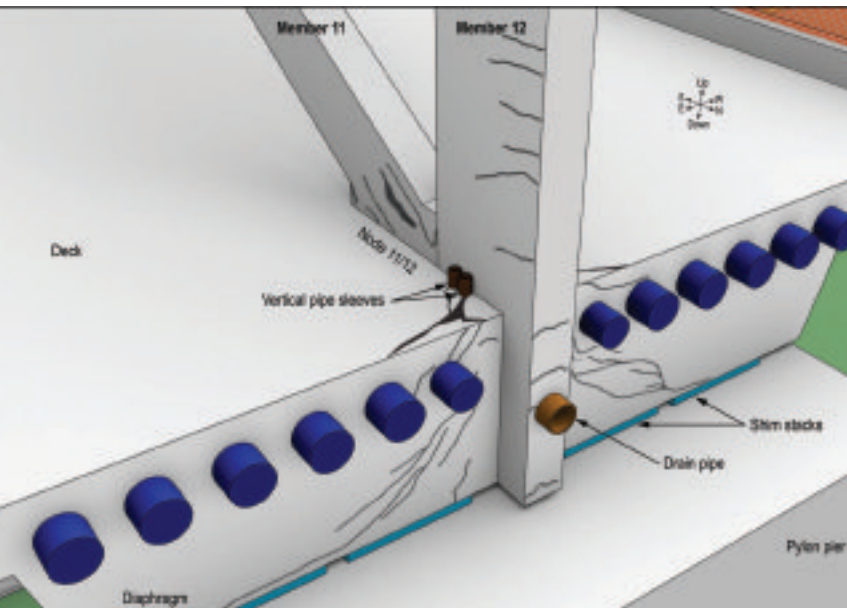
Rendering of cracking at node 11/12 immediately prior to failure, based upon field photo-documentation and measurements (NTSB). Top; the main span was erected overnight using self-propelled modular transporters (FIU)

The cracks around node 11/12 (see opposite page) were monitored by the design engineers and the construction management firm during and after the span erection operation. The cracks did not significantly change from their condition in the casting yard, neither during the span movement operation nor once the span had been placed in its final location upon the piers. Upon de-tensioning the bars in member 11, the construction worker noted that the cracks around node 11/12 had greatly increased in size and severity. He texted photos of the cracks to his supervisor with the message: "It cracked to hell." This occurred on 10 March 2018, five days before the collapse.

The photos show cracks encircling node 11 with crack widths up to 25mm wide and 178mm deep. For comparison, the American bridge inspection standard defines that cracks greater than 5mm wide in concrete structural members shall receive a rating of 'severe', the worst available rating. Cracks of the severity of those found around node 11/12, a non-redundant structural element, indicated that the concrete had exceeded its yield strength and had undergone significant plastic deformation.

The key to mitigating the risk of future bridge collapses requires grappling with root causes. One must dig deeper to move from a proximate cause towards a root cause. One technique for identifying root cause is asking five 'whys'. First, why did the FIU Bridge collapse? Answer: Because truss node number 11-12 failed in shear at the cold-joint with the deck (this is the proximate cause).

The design engineer of record recommended re-tensioning member 11, reasoning that this would restore the main span to the previous condition, when the cracks were smaller. The independent review firm was not notified or involved in this decision. The design engineer of record advised the contractor and the department of transportation that the cracks were not a safety issue. The roadway remained open to traffic.

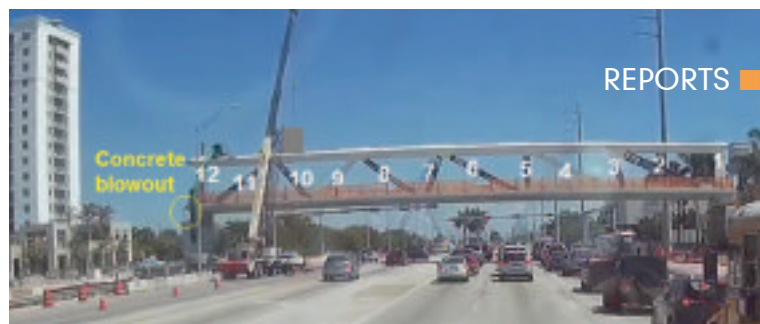
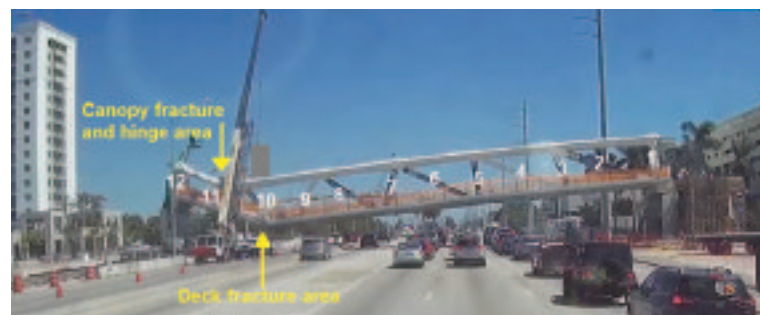
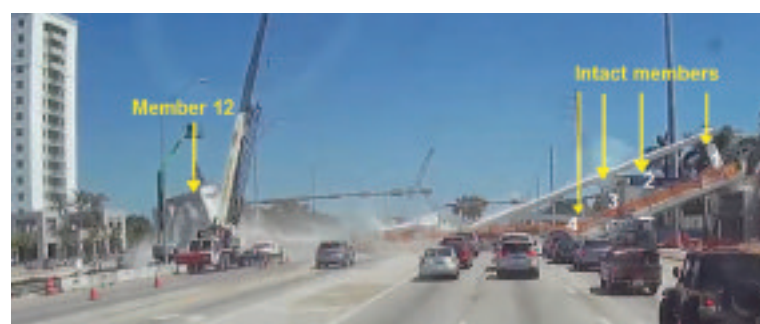
Collapse sequence from in-vehicle video feed - less than two seconds elapsed between the top and bottom images (NTSB)

Moments after completing the re-tensioning of member 11, the main span collapsed on 15 March 2018. The design engineer of record was on an airplane flight home, having visited the site and presented his analysis and recommendations earlier the same morning.

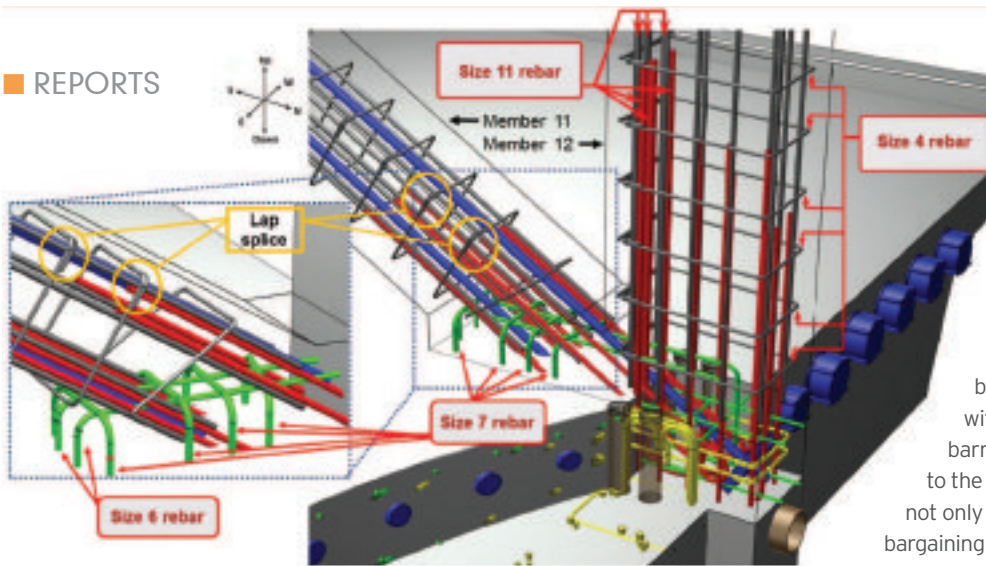
the designer instructed the contractor to roughen to 6mm amplitude and to clean the cold joint surface before the subsequent pour, but this was not done. The later shear failure at node 11/12 occurred at the cold joint where member 11 was bearing upon the deck. The rebar, post-tensioning tendons, post-tensioning bars, and drain pipes embedded in the vicinity of node 11/12 can be seen on page 58.

After the collapse, the Federal Highway Administration calculated that 116cm² of shear steel was required at the interface of node 11/12 and the deck, compared with the 31cm² that was provided in the design.

Rendering of node 11/12 showing internal rebar, post-tensioning bars and tendons, and drain pipes (NTSB)
