**HEAVY MOVABLE STRUCTURES, INC.  
FIFTEEN BIENNIAL SYMPOSIUM**

**Sheave Trunnion Fatigue and Replacement  
at Snohomish River Bridge in Everett,  
Washington**

**Krishna H. Mehta, P.E.  
(Stafford Bandlow Engineering, Inc.)  
Scott Snelling, P.E.  
(Parsons Brinkerhoff)**

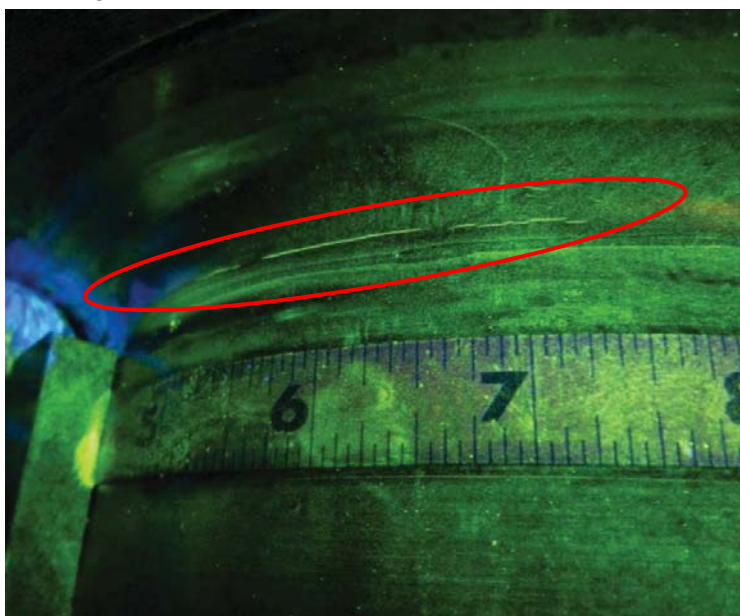
CAPTION: Close up photo of fatigue cracks in the trunnion fillets as indicated during wet magnetic particle type non-destructive examination. Photo by R.Gessel of WJE

- **March 2010:** SBE worked with WJE to perform a complete non-destructive examination of all eight sheave trunnion fillets. The Northeast Inboard trunnion fillet location had the most advanced cracking, with continuous and intermittent cracking over 70% of its circumference. The maximum crack depth was estimated to be 0.125 inches. WSDOT maintenance staff used a “flapper wheel” to attempt to excavate the cracks, but the cracks were deeper than the amount of material that could practically be removed with a “flapper wheel” of approximately 1/16 inch. Dr. John Fisher performed material coupon testing and fracture analysis which concluded that if any trunnion cracks were allowed to extend to 0.5 inches deep, this would result in a safety factor of less than two against brittle fracture, rendering the movable span unsafe for operation. Dr. Fisher calculated that 4041 trunnion stress cycles, equivalent to 1585 movable span full openings (2.55 cycles per opening) could result in the cracks extending to the depth of 0.5in. The average number of movable span openings in recent years was 600 each year, with a maximum number of

- **March 2012:** Parsons Brinckerhoff worked with WJE to perform another non-destructive examination of the trunnion fillets using through-bore ultrasonic examination and wet-magnetic particle examination. Several new cracks were found, compared with the previous examination in October, 2010. The deepest crack was estimated to be 0.165 inches deep. Based on the March 2010 fracture analysis, there were 548 bridge openings remaining before a calculated crack depth of 0.5 inches was reached and the movable span would be categorized as “unsafe for operation.”

Therefore the selected alternative was to replace the existing trunnions, sheaves, ring gear, pinions and trunnion bearings with new components of new design. This allowed the assembly to be assembled in the shop and essentially be a drop in replacement. With this approach the trunnions and sheaves can be fabricated ahead of time and the trunnions can be press fit into the sheave. Simultaneously, the ring gear can be fabricated and press fit into the sheave. Also the trunnion bearings and the pinions can be fabricated and stored prior to any interruptions to traffic at the bridge. Once all the parts are fabricated the bridge can be closed to vehicular and marine traffic as needed to remove the existing components and install the new components.

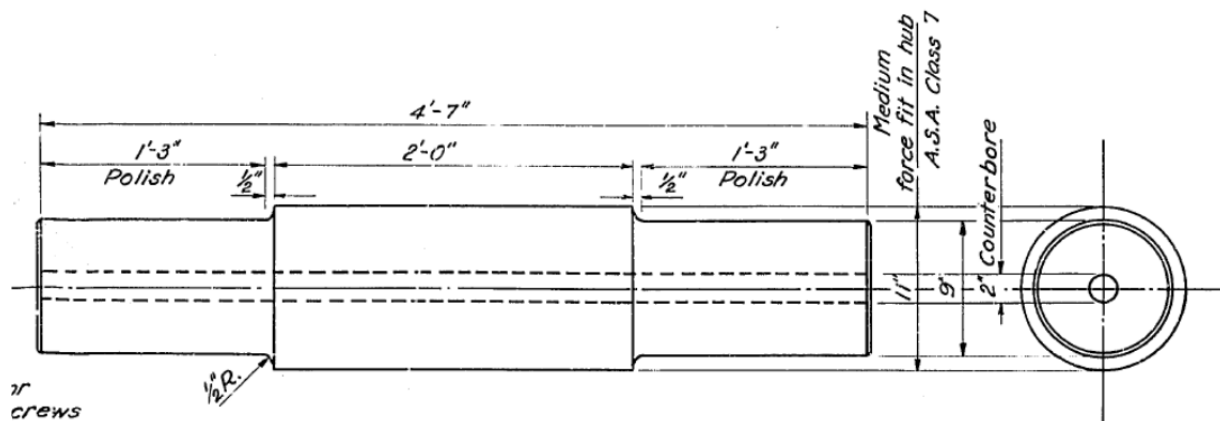
The original design of the subject sheave shafts, circa 1952 predated the application of stress concentration, metal fatigue and fracture mechanic principles within the AASHTO design codes. The current 2008 AASHTO LRFD specification is based on Soderberg fatigue failure theory. Fatigue calculations indicated a nominal bending stress at the fillet of 21 ksi. The 1938 AASHTO, applicable at the time of design, has an allowable stress of 15 ksi for sheave shafts fabricated from heat-treated alloy steel. Therefore, the trunnions were apparently not designed in compliance with the standards in effect at the time. One explanation might be that the designer of the subject sheave shafts applied the 25 ksi allowable stress recommended by O.E. Hovey in his two-volume treatise on movable bridges, published in 1927.

The rehabilitation of the span support machinery consisted of replacing the existing trunnion, sheave and trunnion bearings. The existing trunnions had fatigue cracks at the radius at which the trunnion transitions from the sheave fit to the bearing journal.

CAPTION: Design drawing of the original trunnion from 1953. The trunnion fillet radius is 1/2".

To prevent the new trunnions from cracking due to fatigue the new trunnion were designed to be larger in diameter, have a more generous radius at the transition from the sheave shrink fit to the bearing journal and were made of stronger material. The new trunnions were sized to meet the current AASHTO standards. The current AASHTO standard states that the trunnion shaft should have an infinite fatigue life. The new trunnion needed to be able to fit in the space constraints dictated by the existing trunnion bearing supports. The new trunnion needed to have a 24in long trunnion hub and needed to have the same trunnion bearing spacing as existing. The new trunnion also needed to have an FN3 fit with the sheave to meet AASHTO requirements. All of these requirements have been added to the new trunnion as shown below.

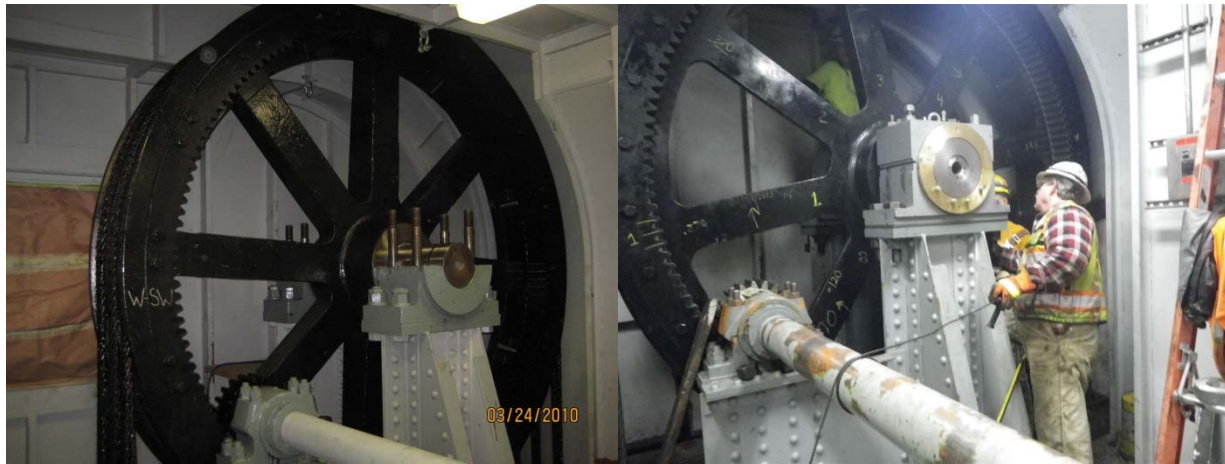
CAPTION: Original sheave, trunnion, and trunnion bearing.

New sheaves were provided and meet the requirements of the current AASHTO standard and fit in the existing space constraints. The existing sheaves were made from steel casting; however few foundries remain in the USA capable of producing a ten-foot diameter casting. However, many fabricators continue to have the capability to fabricate a sheave of welded construction. Therefore a welded sheave design was developed to fit into the available space and match the critical geometric demission of the existing structure. The new sheave is designed to take the loads imparted on it, accommodates the internal gear ring gear and has a larger hub than the existing sheave to meet AASHTO requirement. It also has an FN3 fit with the trunnion and three 1  $\frac{1}{2}$ " pressfit dowels.

CAPTION: New sheave, trunnion, and trunnion bearing.

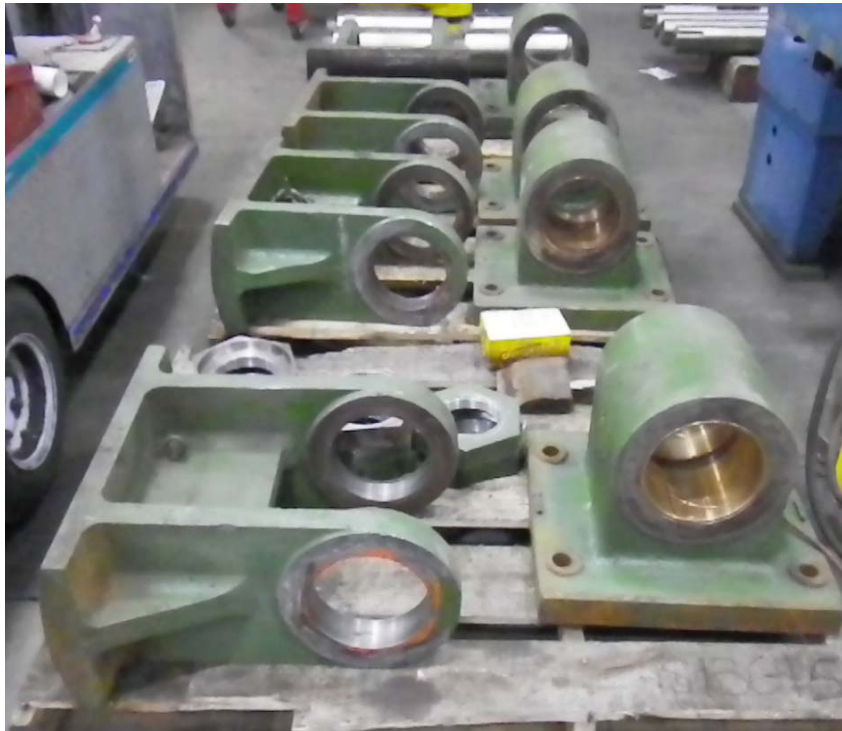
The four live load shoes for the lift span are all rocker-type with curved bearing surfaces. However, once the counterweight was to be jacked and the ropes removed, four rocker-type bearings is no longer a stable configuration. In addition, the shoes would temporarily be required to support the dead load of the movable span, in addition to the live load. The line-contact portion of the live load shoes would be overstressed by the added dead load. Therefore, the design of temporary dead load plus live load shoes was included in the scope of the project. In addition, the existing live load shoes were seized and in need of rehabilitation to free the shoes to allow rotation and provide for improved lubrication details to the pins to prevent recurrence of the seizing issue.

CAPTION: Live Load  
Shoes disassembled in the  
shop

Unlike a typical simple span bridge with two fixed bearings and two free expansion bearings, each of the four existing live load shoes for the Snohomish River Bridge were rocker type to allow for free expansion. However, the pins were seized and no longer allowed for expansion. In addition, the grease grooves were plugged and were no longer accepting lubrication. Therefore, the scope of this project included removing the existing live load shoes, disassembling, improving the bearing and lubrication details, and re-installing the refurbished shoes.
