**HEAVY MOVABLE STRUCTURES, INC.  
FIFTEEN BIENNIAL SYMPOSIUM**

**Sheave Trunnion Fatigue and Replacement  
at Snohomish River Bridge in Everett,  
Washington**

**Krishna H. Mehta, P.E.  
(Stafford Bandlow Engineering, Inc.)  
Scott Snelling, P.E.  
(Parsons Brinkerhoff)**

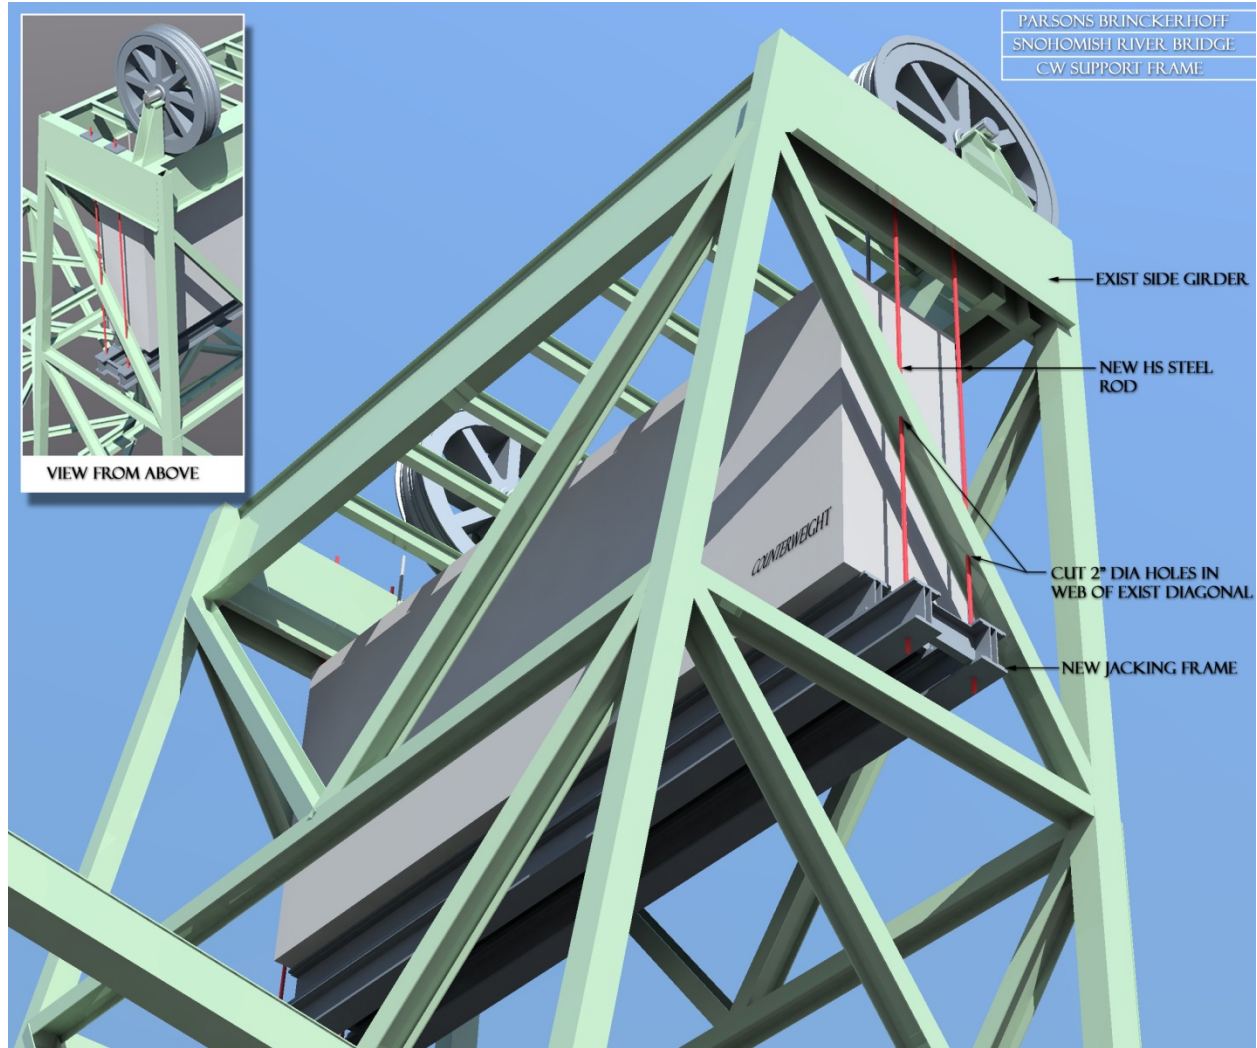
CAPTION: Preliminary 3D Model of the Temporary Counterweight Support Design – Early in the Design Process (Existing Wind Guides and Temporary Lateral Support Not Shown)

Key attributes of the temporary counterweight support design included redundancy of the high strength rods and the ability to distribute the point loads imposed by the high strength rods. The quantity of four high strength rods used to provide temporary support, was the maximum feasible quantity, due to the limited geometric space envelope provided due to the close proximity of the tower diagonal and horizontal truss members. Given the opportunity, additional rods would have been used to provide additional redundancy. However, even with only four rods, it was possible to design for redundancy even in the extreme case of the complete failure of one rod. Note that the failure of one rod would result in zero load in the rod on the opposing corner and a doubling of the load in the other two remaining rods.

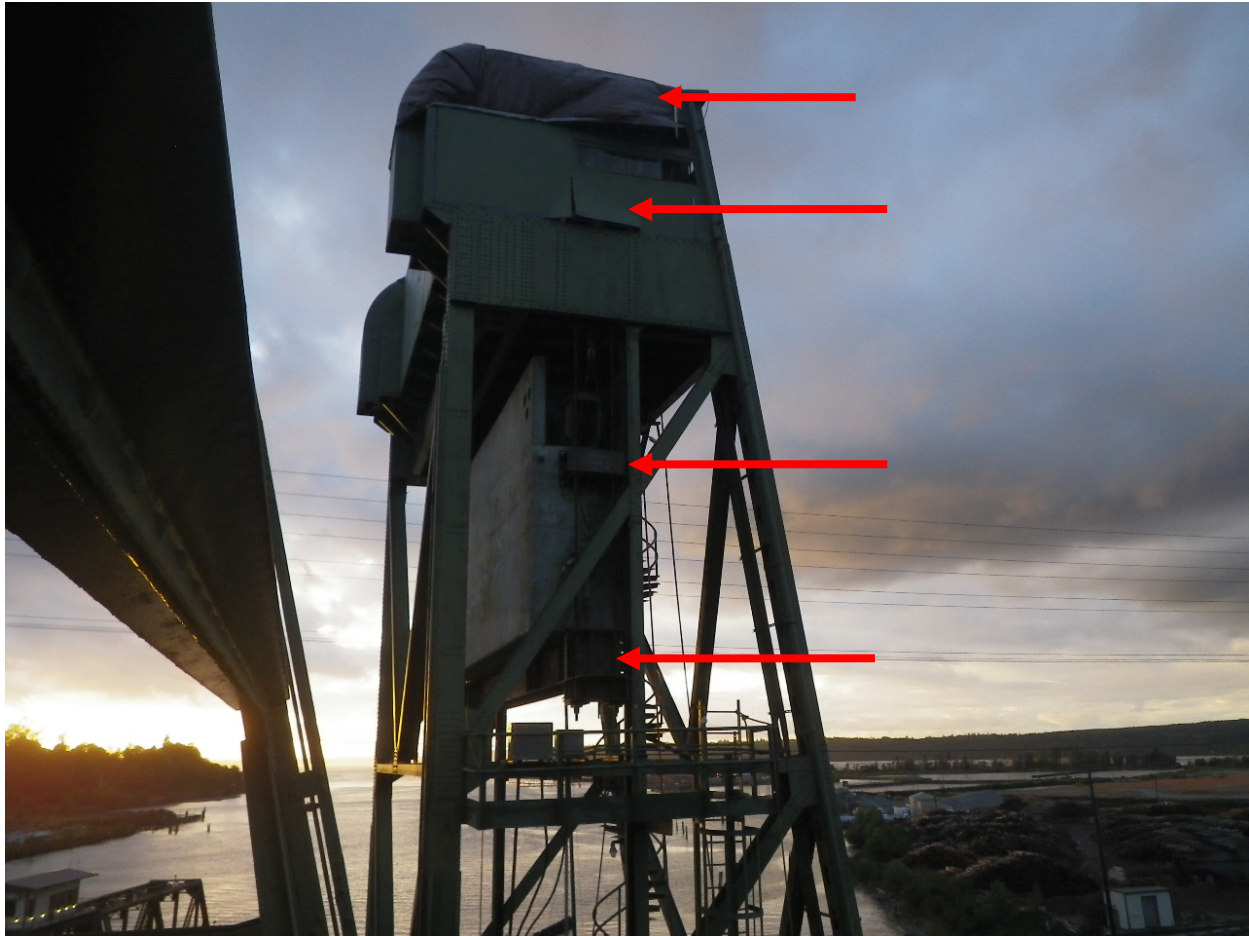
CAPTION: Counterweight temporarily supported during construction with ropes removed. From top to bottom, note: (1) machinery room roof partially removed with tarp for temporary weather protection, (2) machinery room wall cut to make room for bar jacks, (3) temporary lateral support, (4) temporary counterweight support beam.

Due to the tall and slender profile of the existing counterweight, as well as potential instability related to the considered rod failure case, it was necessary to also provide temporary lateral supports to prevent overturning of the counterweight. The lateral supports were conservatively designed to support 25% of the vertical dead load, which approximately translates to a rotation of 14 degrees from plumb.

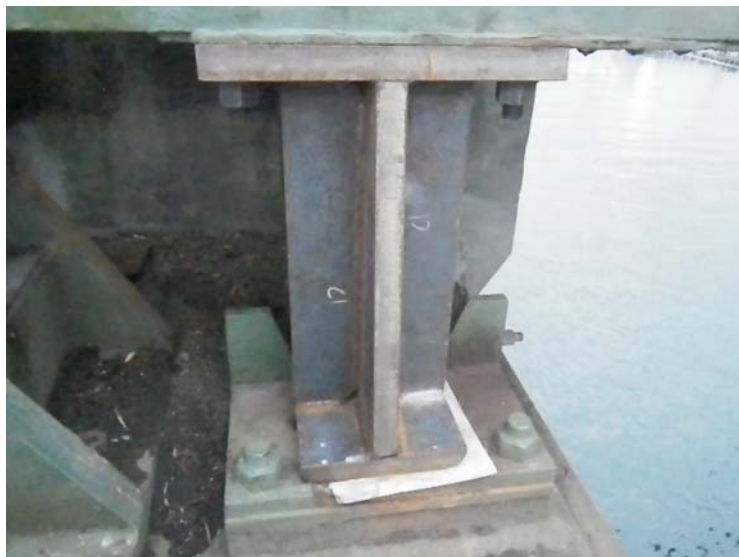
CAPTION: Temporary DL+LL Shoe installed on the bridge.

During the shop drawing phase of the project, the Contractor instead proposed to simultaneously perform work at both towers, which necessitated alterations to the DL+LL shoes to allow for free-expansion. In the end, this was accomplished using PTFE (aka. Teflon) sheeting between the shoes and strike plates.

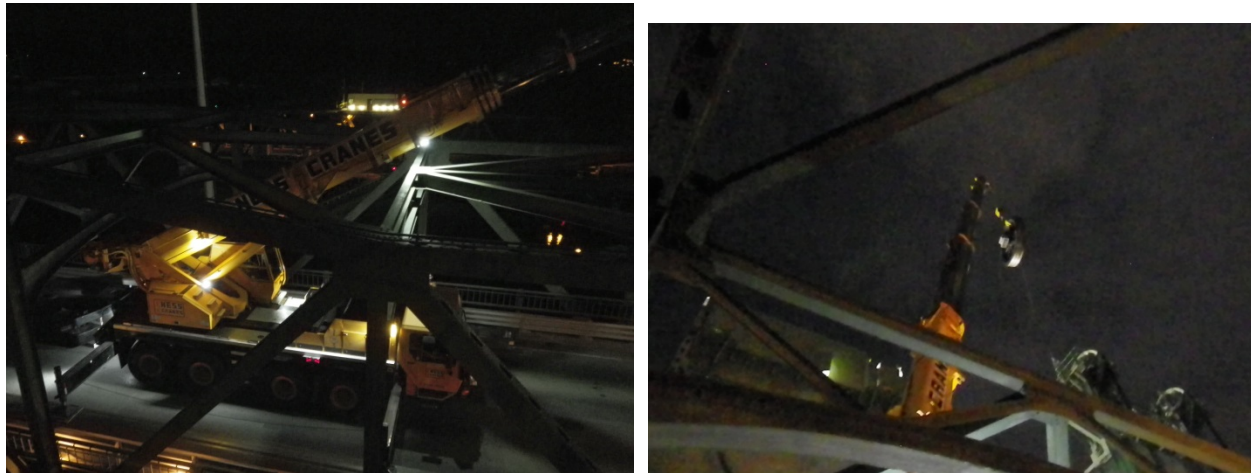
CAPTION: The Contractor used a boom crane that is setup on the span to replace the sheave trunnion assemblies.

Being able to lift the sheave trunnion assemblies from roadway to tower level by the use of a rubber-tired boom crane from the bridge deck instead of a barge mounted crane allowed the Contractor to save a significant amount of construction cost.
